Case Study: SFRA the modern Crystal Ball

On 19 February 2007, a 275/132 kV, 315 MVA 3 phase auto transformer, manufactured in 1982, tripped on differential protection (red and blue phases), main tank and tap change pressure. The tapchanger was made up of the selector residing in the main tank and diverters isolated in a partitioned compartment. The strategic importance of this transformer required decisive and prompt decision on the condition and suitable interventions. Congru engineers were requested to aid in this process.

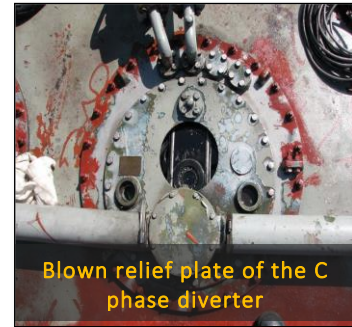
Step 1: Purely from a visual inspection the fault caused a blowout of the pressure relief plate on the C phase diverter and the main tank pressure relief valve had operated. Damage to the diverter could damage the selector and more importantly the vulnerable tap windings. The condition of the other phases also needs to be checked.

Blown relief plate of the C phase diverter

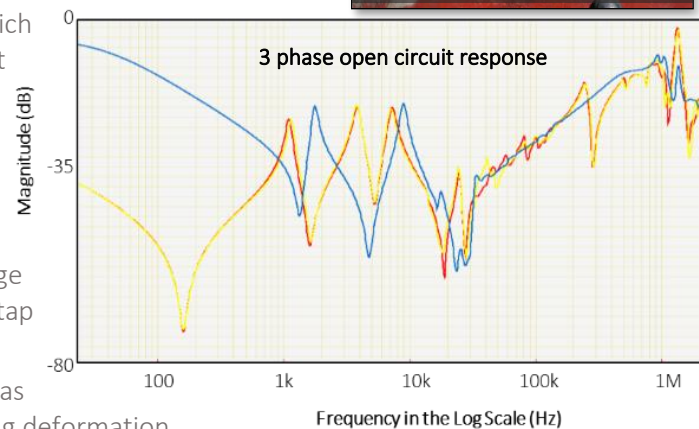
Step 3: Diagnostic: An increase in power factor for all the winding which was expected. Exciting current revealed an increase of current on the C phase. The ratio measurements were also affected by the C phase diverter as expected. The SFRA revealed a short circuit which is attributed to the diverter and not the windings. What was of greater interest was the absence of resonant points of the C phase between 200kHz and 1MHz. Clear indications of winding deformation. Based on the damage to the diverter the conclusion can be drawn is that the tap winding could be deformed.

Predictive: The transformer cannot be returned to service as there is extensive damage to the diverter and possibly winding deformation.

Prescriptive: An internal inspection is required to determine the level of damage and to ascertain if repairs can be done on site or should the unit be sent to the factory for a detailed inspection and repair. The internal inspection must focus on the selectors for signs of damage, ruptured barrier board between main tank and diverter compartment and the HV winding for deformation.

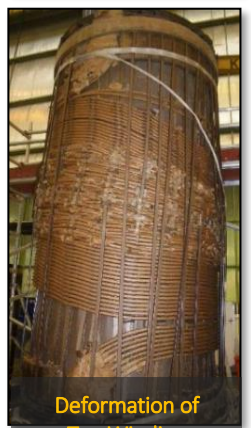
Deformation of Tap Winding

The customer was faced with a dilemma of either doing the necessary repairs onsite by replacing the selector and diverter of the C phase or sending the unit to the factory for a detailed inspection and repair. The former has two advantages in that it will be firstly significantly cheaper and secondly quicker to return to service. However, the customer had belief in the Congru technical team and opted to send the transformer to the factory for a detailed inspection. The detailed inspection revealed that the tap winding has suffered an axial collapse and needed to be rewound. If the customer had opted to perform onsite repairs the transformer would have suffered a catastrophic failure possibly on energisation which would have resulted in the increase in repair cost and longer delays. So SFRA was the saving grace by allowing us to visualize what we cannot see in this case the tap winding. The crystal ball!
